## **SECTION 3. ASSESSMENTS OF WATERBODIES AND WATERSHEDS, 5TH ORDER HUC**

### **3.1 §303(d) Listed Streams Proposed for De-listing, with Sediment as the Listed Pollutant of Concern: Includes Streams De-listed in the DEQ 1998 §303(d) List**

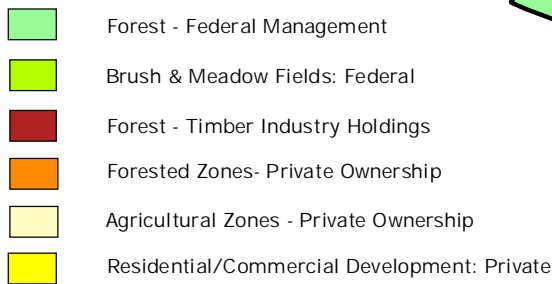
**Figure 3-9b.** General land use and ownership in the Reeder Creek watershed.

Reeder Creek watershed is a mixture of federal lands and private ownership (Figure 3-9b). A substantial area of land is private (2,253 acres, 27% of the watershed). Land use on private ownership includes: a minor amount of urbanization with scattered single family residences, and a single small subdivision near the mouth of Reeder Creek; some non-industrial private timber harvesting; and a 900 acre brush/agricultural zone with hay cropping and minor grazing. Two blocks of industrial timber lands (552 acres, Stimson Lumber Company) are located in the southeast hillslopes. The remaining 6,038 acres is under USFS management with most land managed for timber production, but federal land also includes flat brush fields and meadows. Federal land at the mouth of Reeder Creek is leased to Elkins Resort, with cabins and driveways immediately adjacent to the stream.
